LEVEL ONE EARTHWORKS COMPLIANCE REPORT

DL19/070 – Bulk Earthworks Filling Operations

Woodlinks Village – Stage 15

Collingwood Park

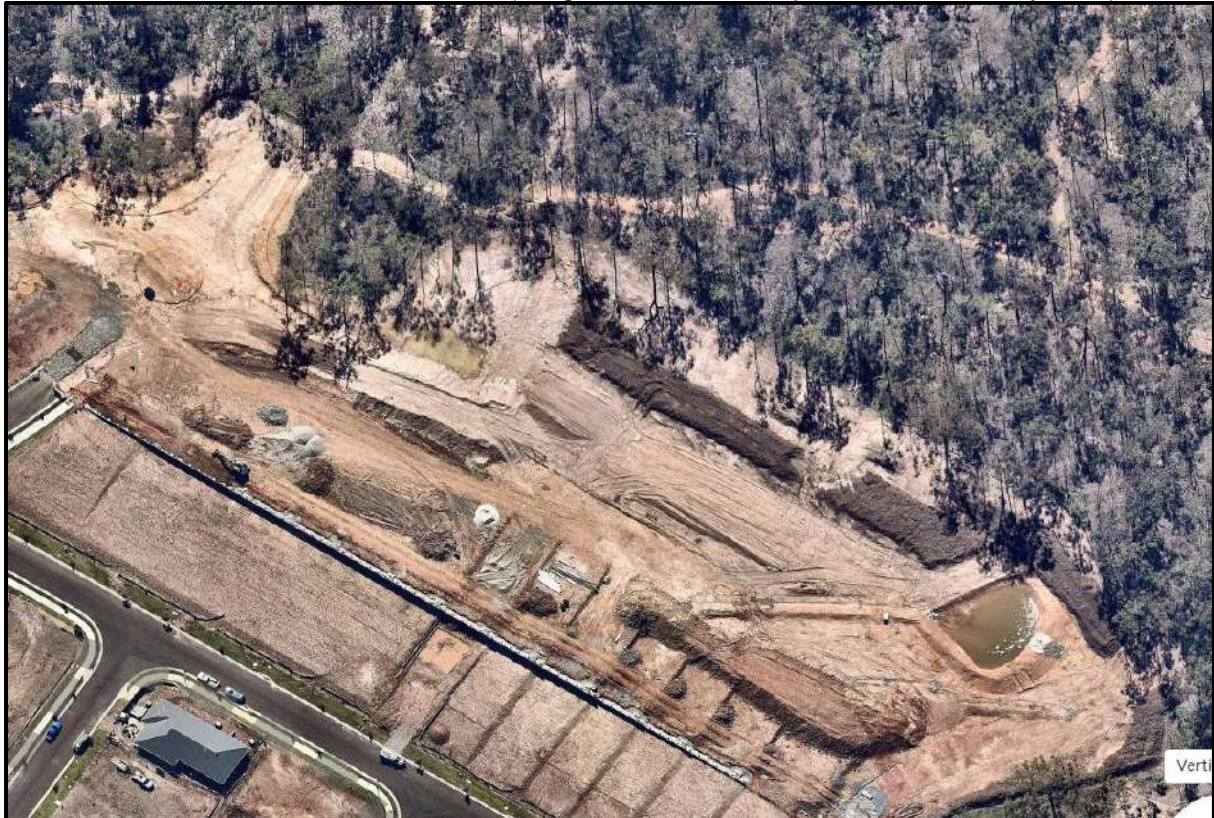
Picture 1: Aerial View of the Site (Image Source: Nearmap.com- dated 5th May 2019)

This report presents results of Level One Earthworks Inspections and associated Compaction Compliance testing carried out on Earthworks Fill constructed to form residential building platforms and embankments below subgrade at the Woodlinks Village Stage 15 Development (The Site).

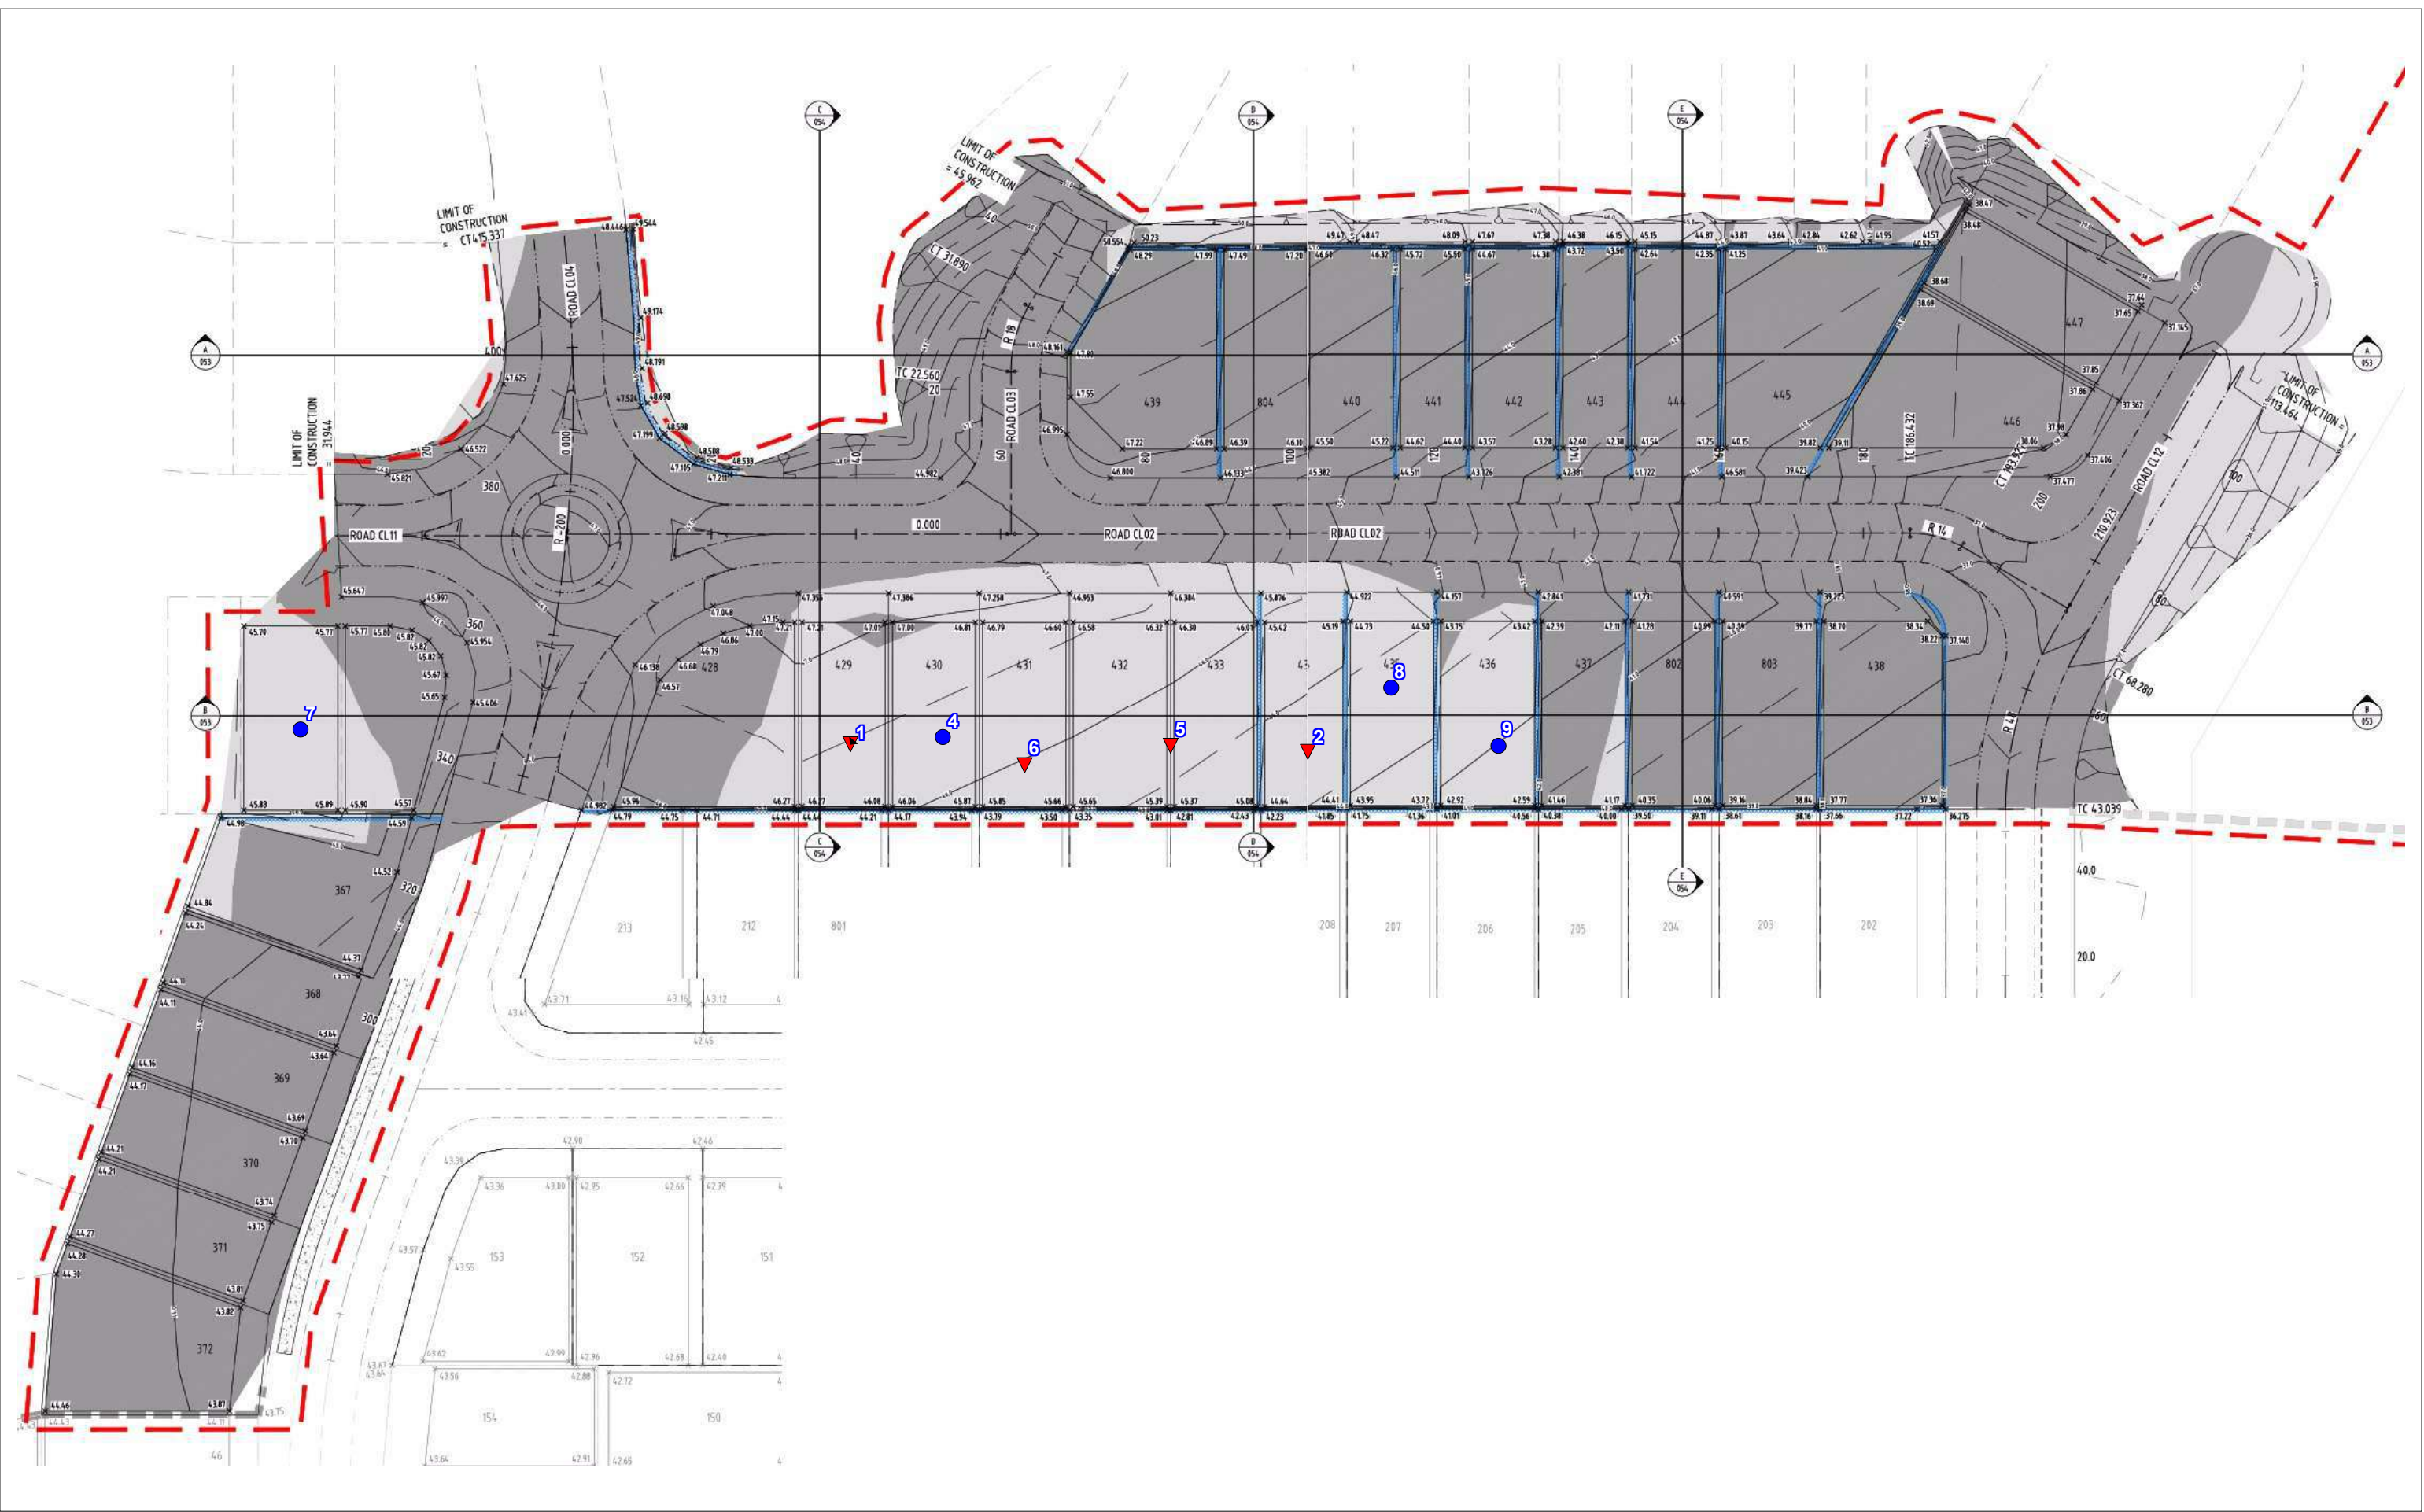
Appendix A – Site Plan Showing Test Locations

The Location of the field density tests are shown on the Site Plan contained in Appendix A. These test locations and levels were not obtained by survey and therefore should only be considered as approximate.

Map Description :	EARTHWORKS FIELD DENSITY TESTING - Level 1 Inspection		
Client :	GOLDING CONTRACTORS		
Project :	WOODLINKS STAGE 15		
Project No :	DL19/070	Drawing No :	DL19/070-01
		Scale :	Not to Scale
